### **Mud Build-Up Inside Front Door - New Seal**

Bulletin No.: 431006

DIRT BUILD-UP ON ROCKER AND LOWER INBOARD DOOR SURFACE (INSTALL FOAM SEAL)

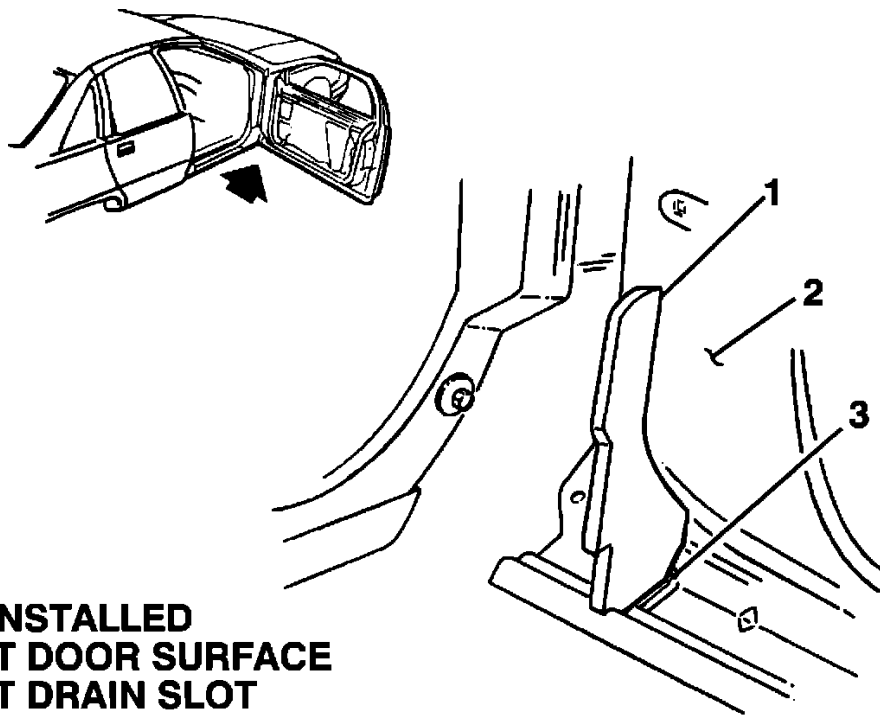
**Figure 1**

Some owners may express dissatisfaction with mud collected along inside bottom of front door and rocker.

5. Align the foam seal vertically to the front lower door surface and install it just forward of the front drain hole. (See illustration.) After installation, press seal firmly to fully seat the seal to the door.

In some cases it may be necessary to adjust the door inboard so that the lower auxiliary contacts the rocker.
