Transmission and Drivetrain: All Technical Service Bulletins Transmission Fluid Leak From Pump Body Replace Bushing

Bulletin No.: 57-71-26B

Subject:
Transmission Fluid Leak from Pump Body (Replace Bushing)

Models:
1995-96 Buick Road master
1995-96 Cadillac Fleetwood
1995-96 Chevrolet Caprice, Camaro, Corvette
1995-96 Pontiac Firebird

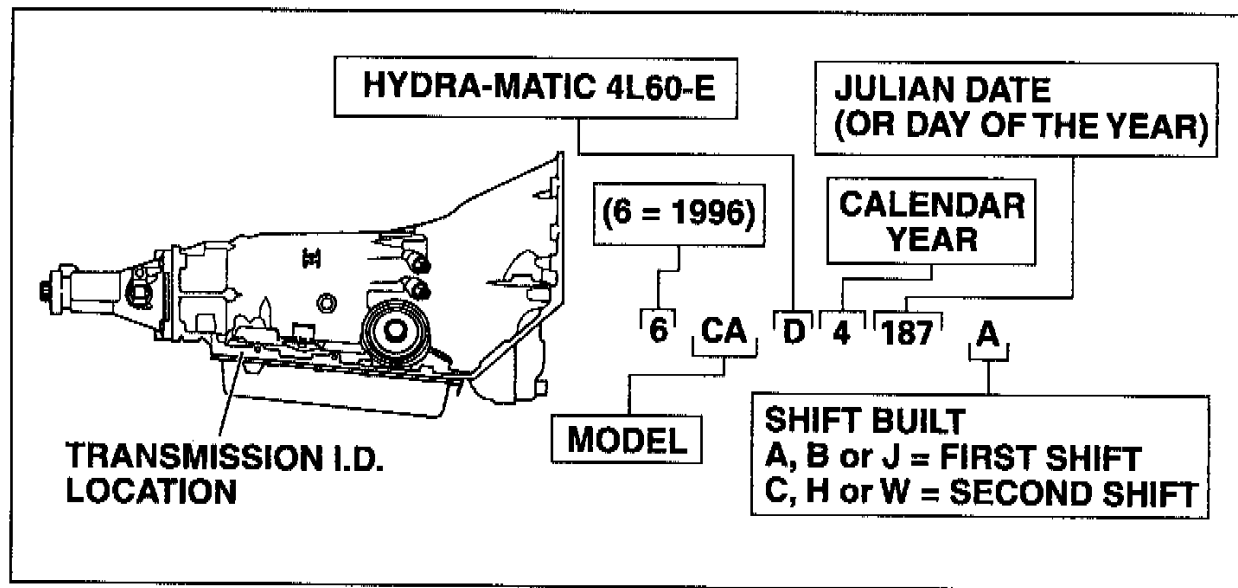
Figure 1 - Hydra-Matic 4L60-E Transmission Identification Information

(Figure 1) Some owners may experience a pump fluid leak. Starting September 11, 1995 (Julian Date 254) all units are built using a revised design body bushing.

The pump bushing is spinning or walking out of the body.

Replace the pump body bushing using Kent-Moore tool J 41778.
