## **Vehicle: All Technical Service Bulletins**

### **Engine Noise**

Bulletin No.: 67-61-14B

Engine Noise (Install Valve Stem Oil Seal)

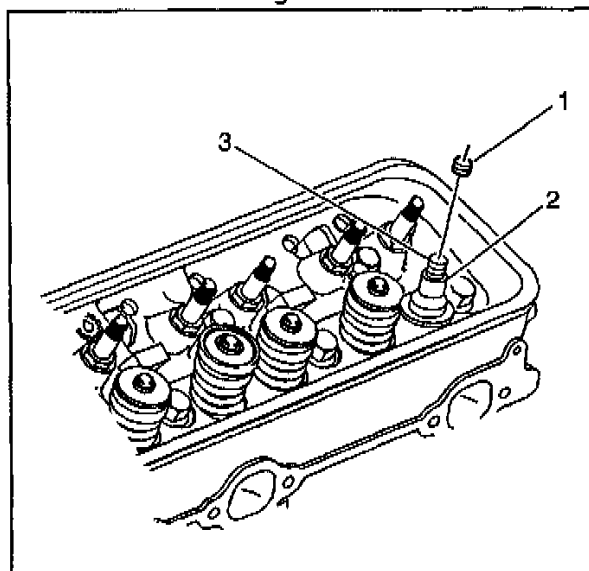
**Figure 1**

The noise may be caused by a low level of lubrication on the exhaust valve stem, creating a "slip-stick" condition between the valve stem and valve guide.

Install the valve stem oil seal listed below, ON THE EXHAUST VALVE GUIDES ONLY.

Lightly lubricate the seal, and with finger pressure only, push it on to the valve stem and down on to the exhaust valve guide. (See Figure 1)

DO NOT install this seal on intake valve guides. This seal is NOT released for intake valve application in the above identified vehicles.
