## Transmission and Drivetrain: All Technical Service Bulletins

Bulletin No.: 67-71-47

3-2 Part Throttle Downshift Flare (Replace 3-2 Solenoid)

with HYDRA-MATIC 4L60-E (RPO M30)

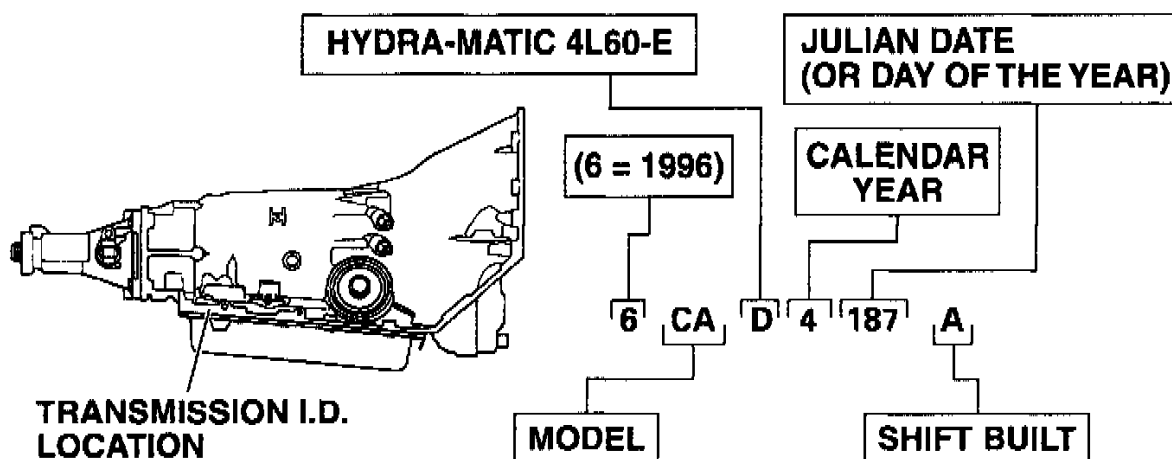
Figure 1 - Hydra-Matic 4L60-E Transmission Identification Information

Condition (Figures 1 and 2)

Some owners of the above models with a HYDRA-MATIC 4L60-E transmission (built before May 24, 1996/Julian Date 6145) may experience an engine speed flare of 1000-2000 RPM, during a part throttle downshift at 19-31 mph. This condition will not set any DTC's (Diagnostic Trouble Codes).

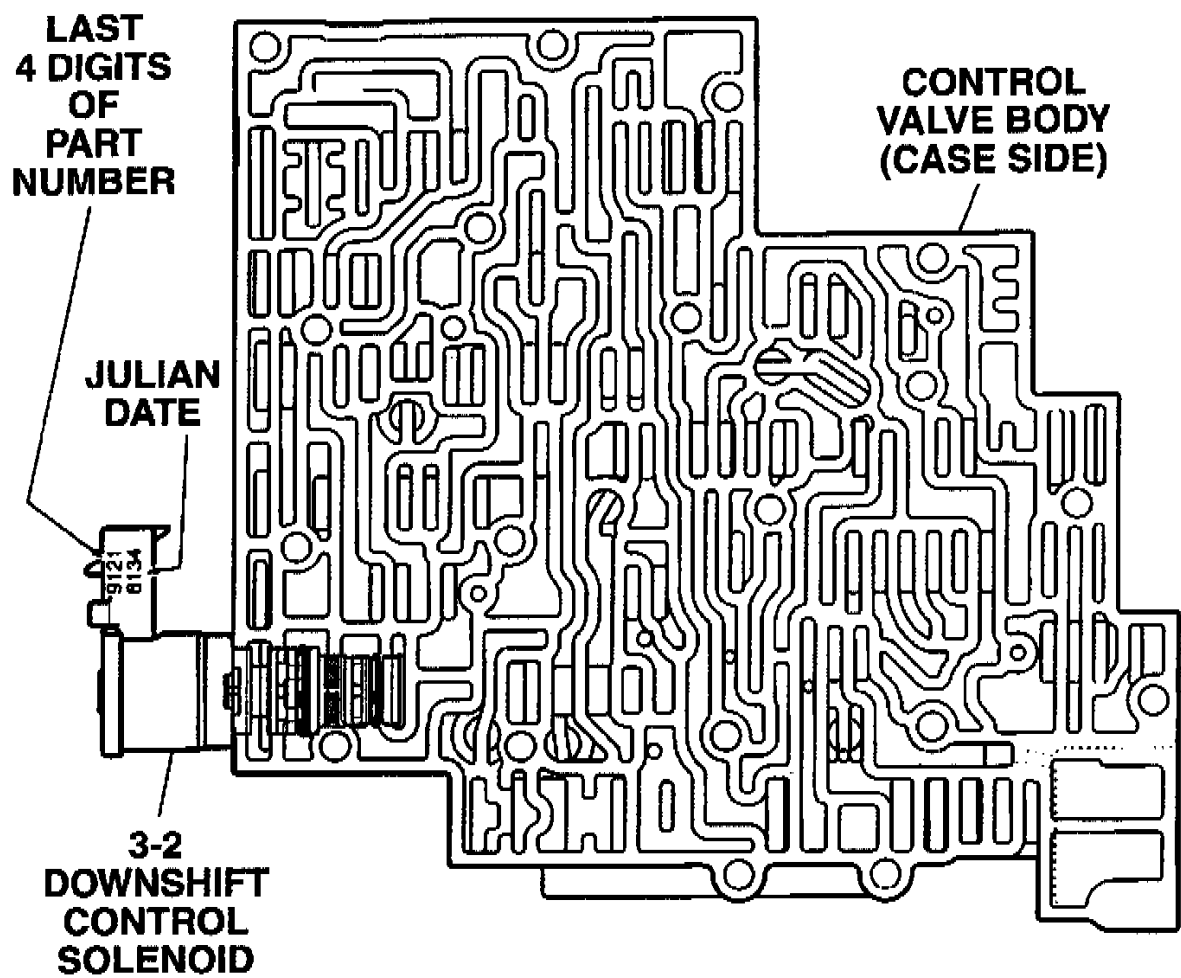
**Figure 3 - Location and Identification of the 3-2 Control Solenoid on the Control Valve Body**

Exhaust seat on the 3-2 control solenoid backing out.

Correction (Figure 3)

Replace the 3-2 control solenoid. Julian Date on the solenoid will be May 13, 1996 (6134) or later.
